BUREAU OF SHIPS GROUP TECHNICAL INSPECTION REPORT

OPERATION CROSSROADS. U.S.S. INDEPENDENCE (CVL22)

TEST ABLE

VOLUME 1 OF 4 [U].

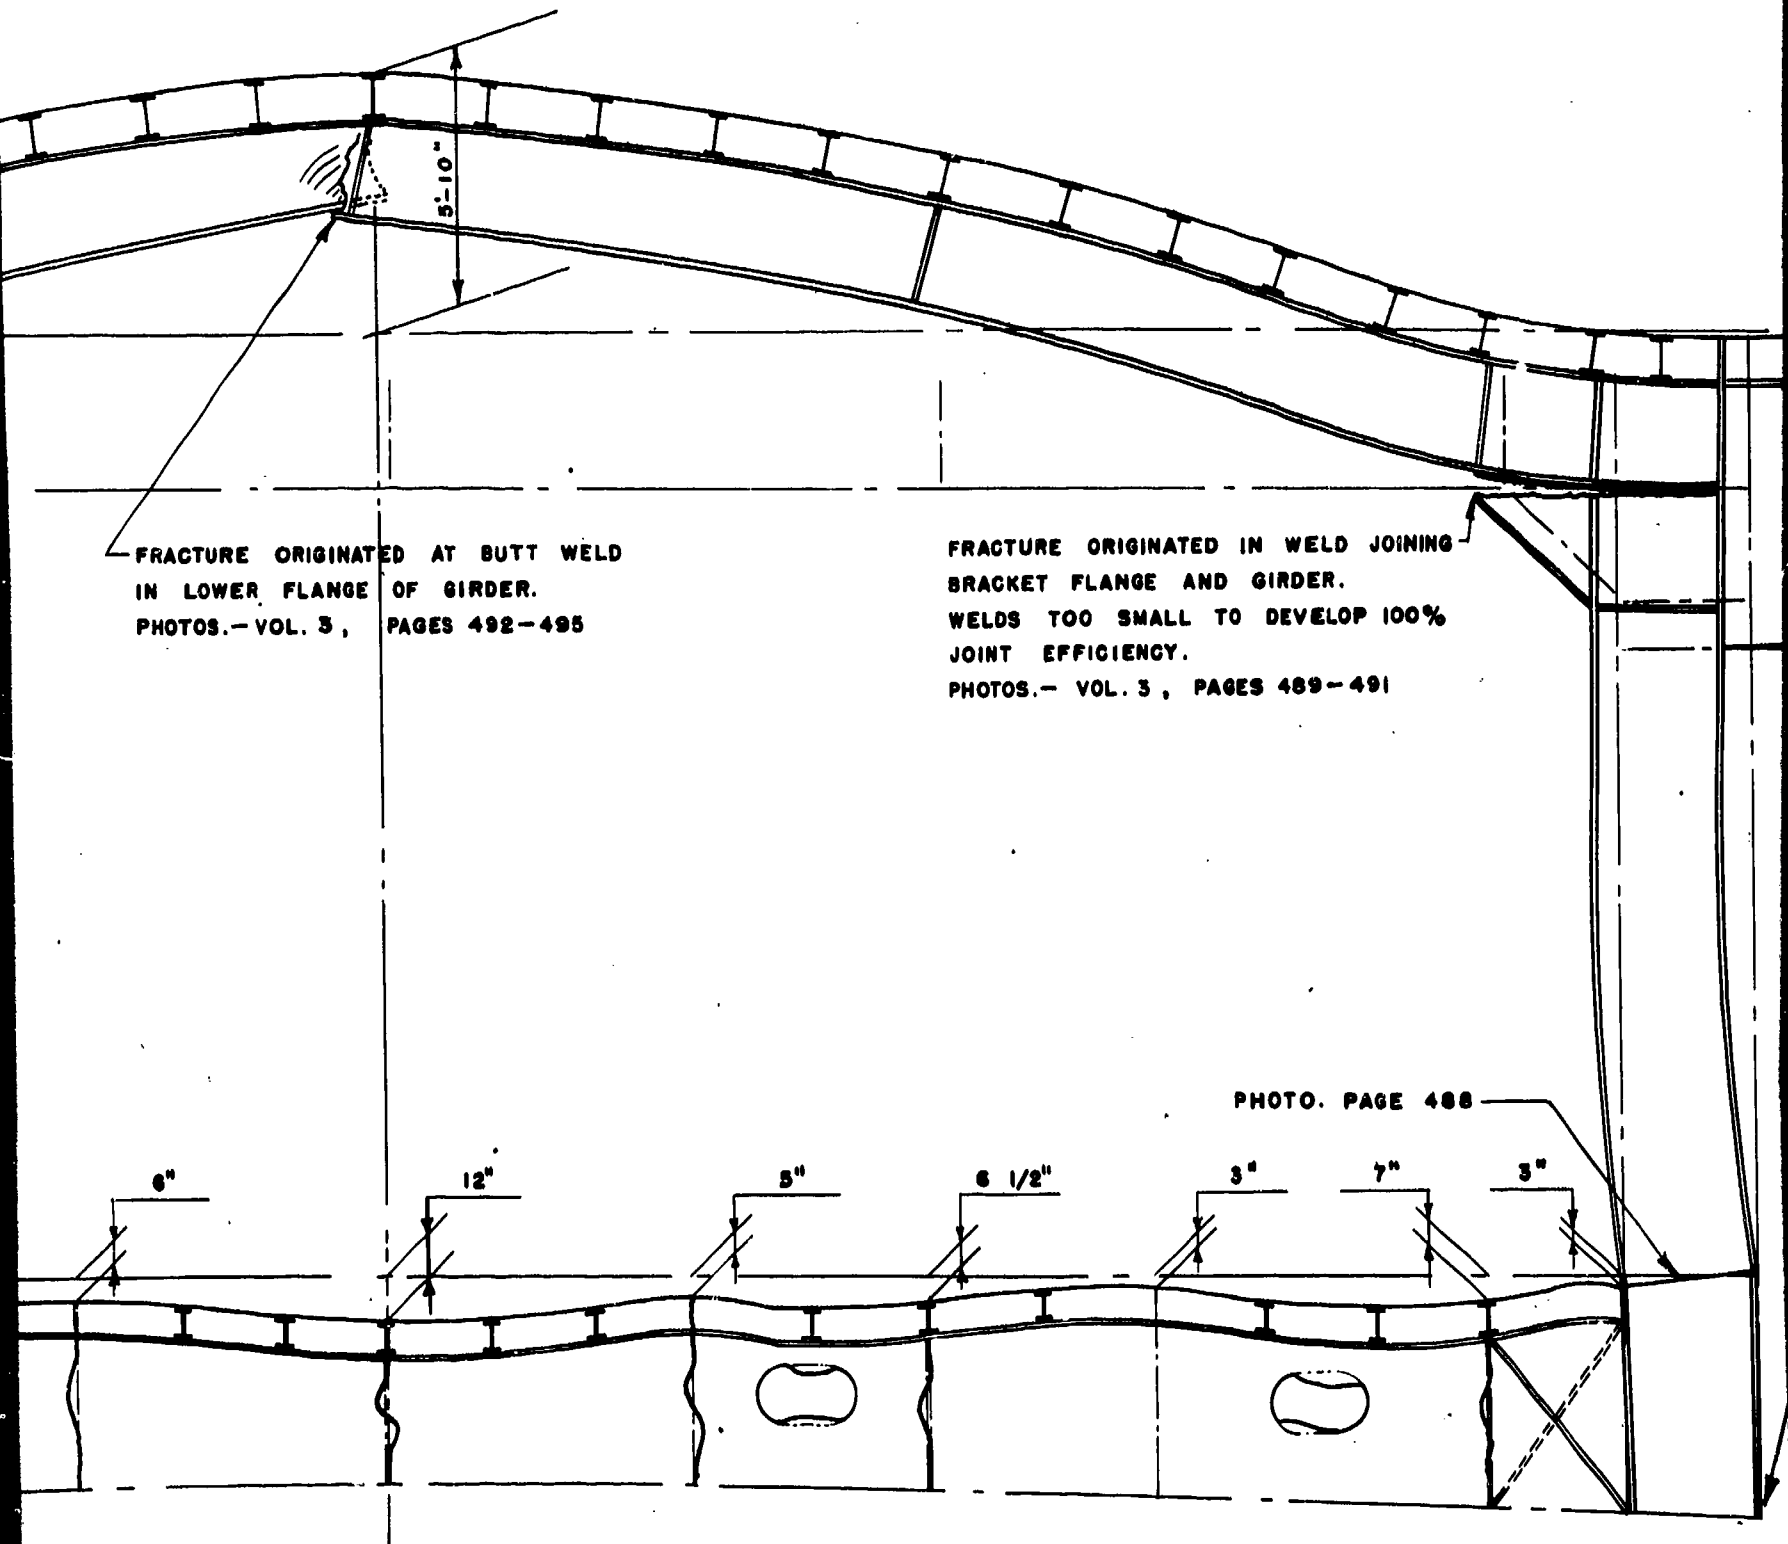
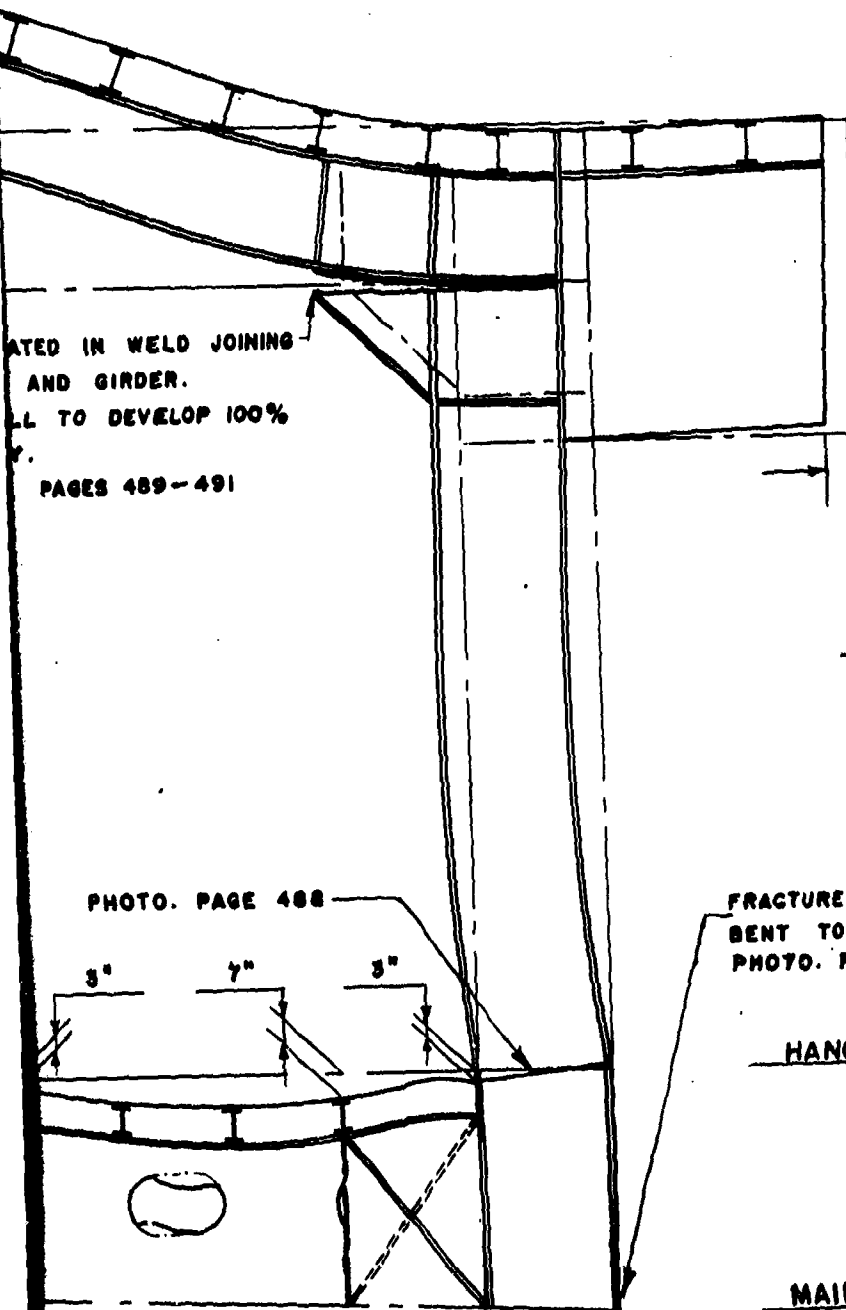
TRANSVERSE SECTION AT FR. 98
LOOKING AFT

FRACTURE IN C.R.S. WELD JOINING
BENT TO S.T.S. SHEER STRAKE.
PHOTO. PAGE 487

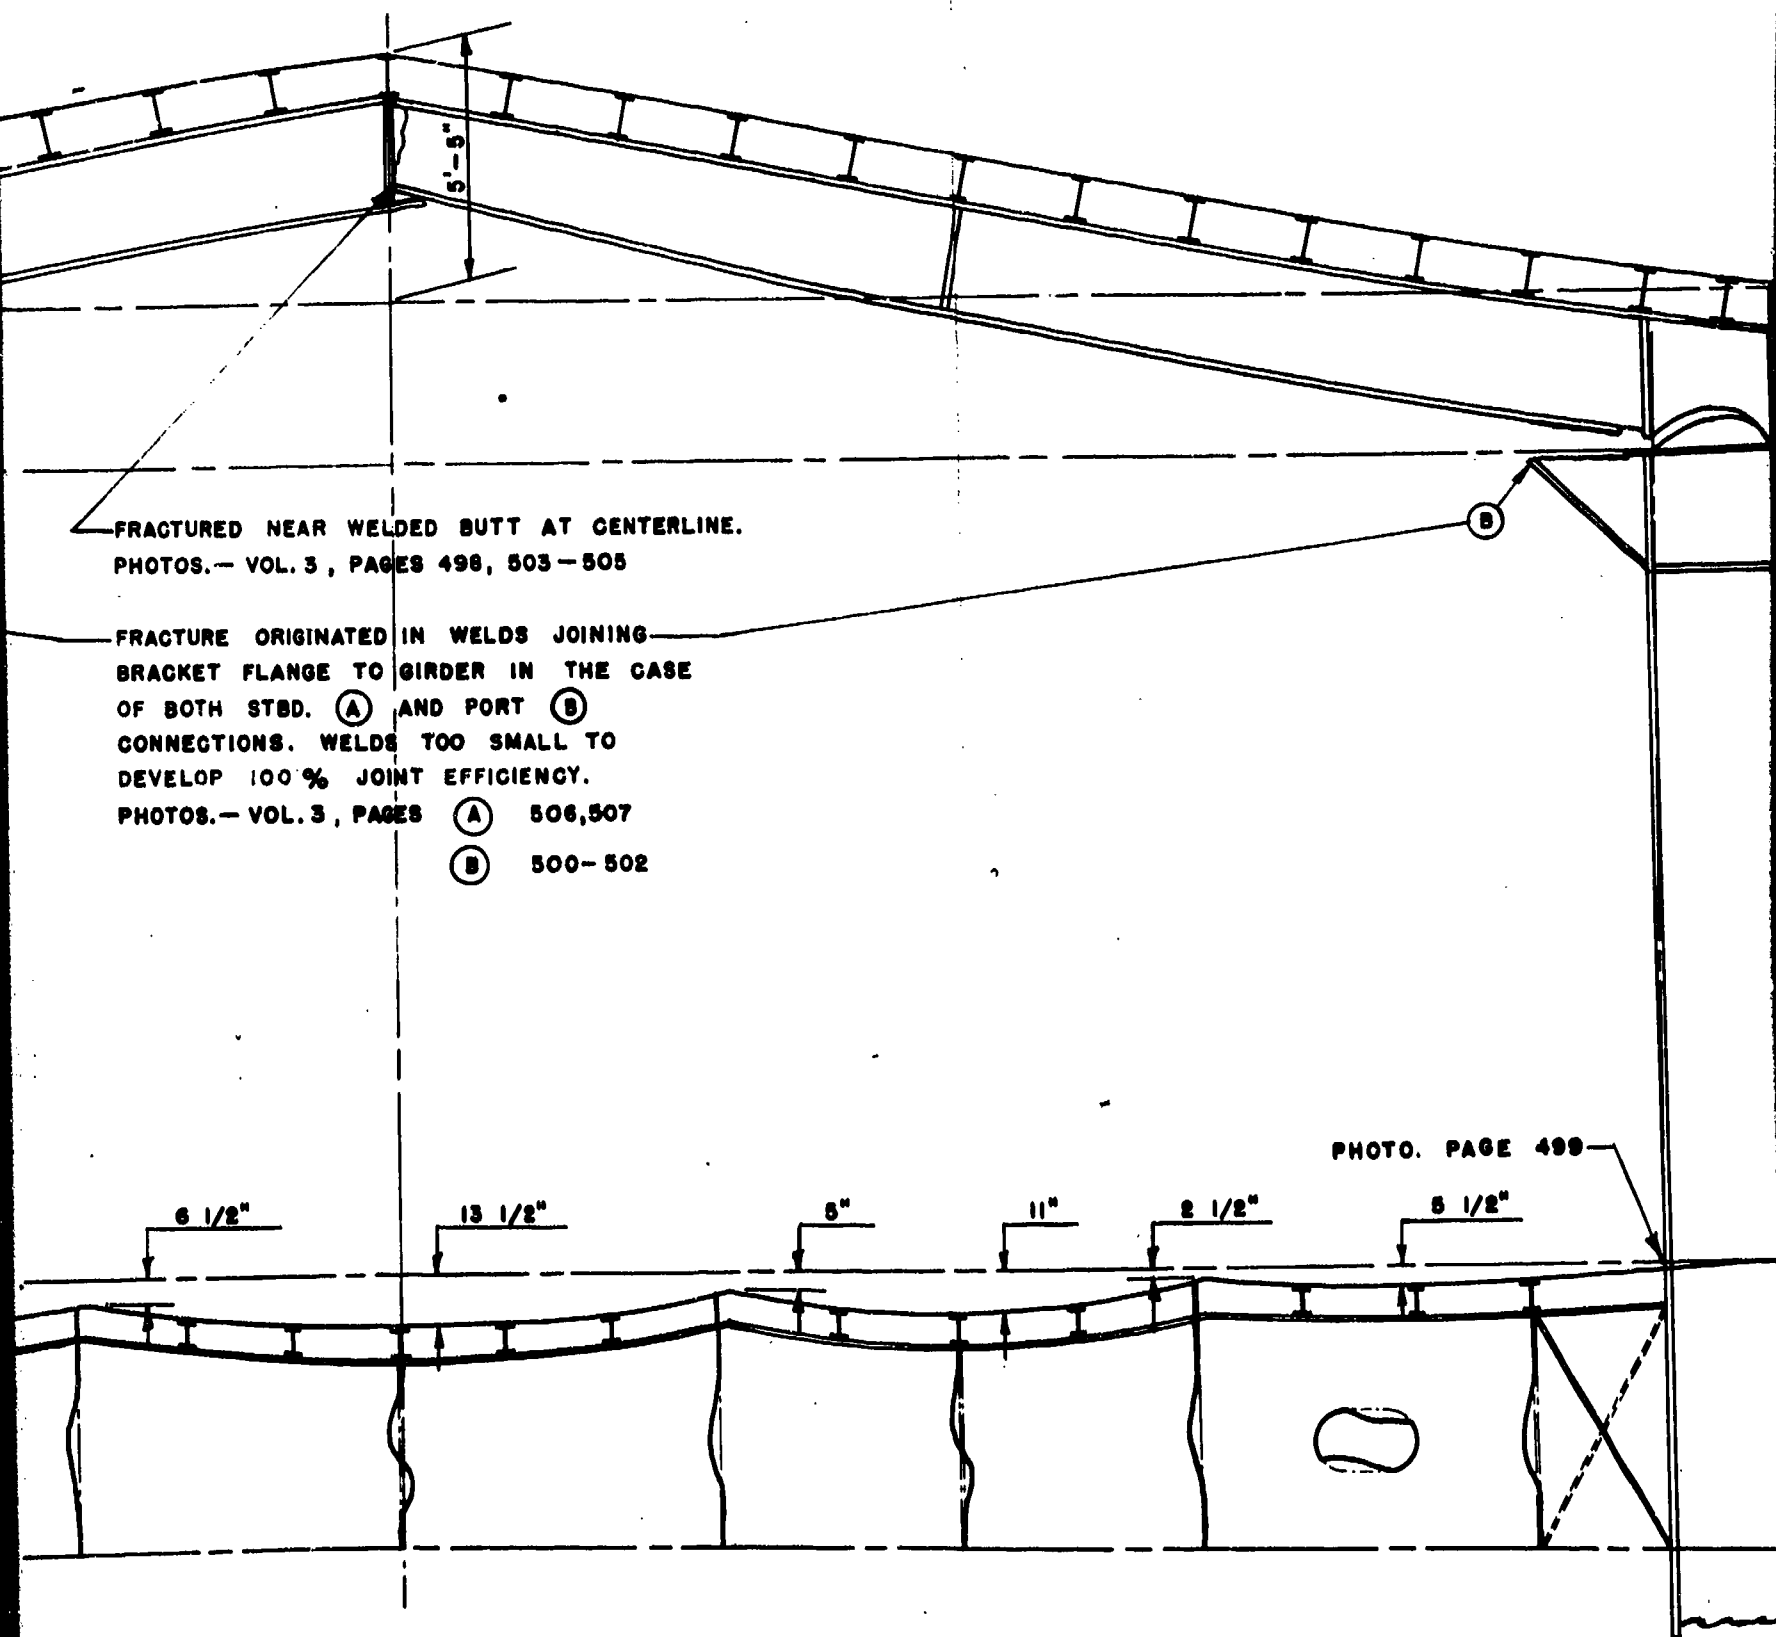
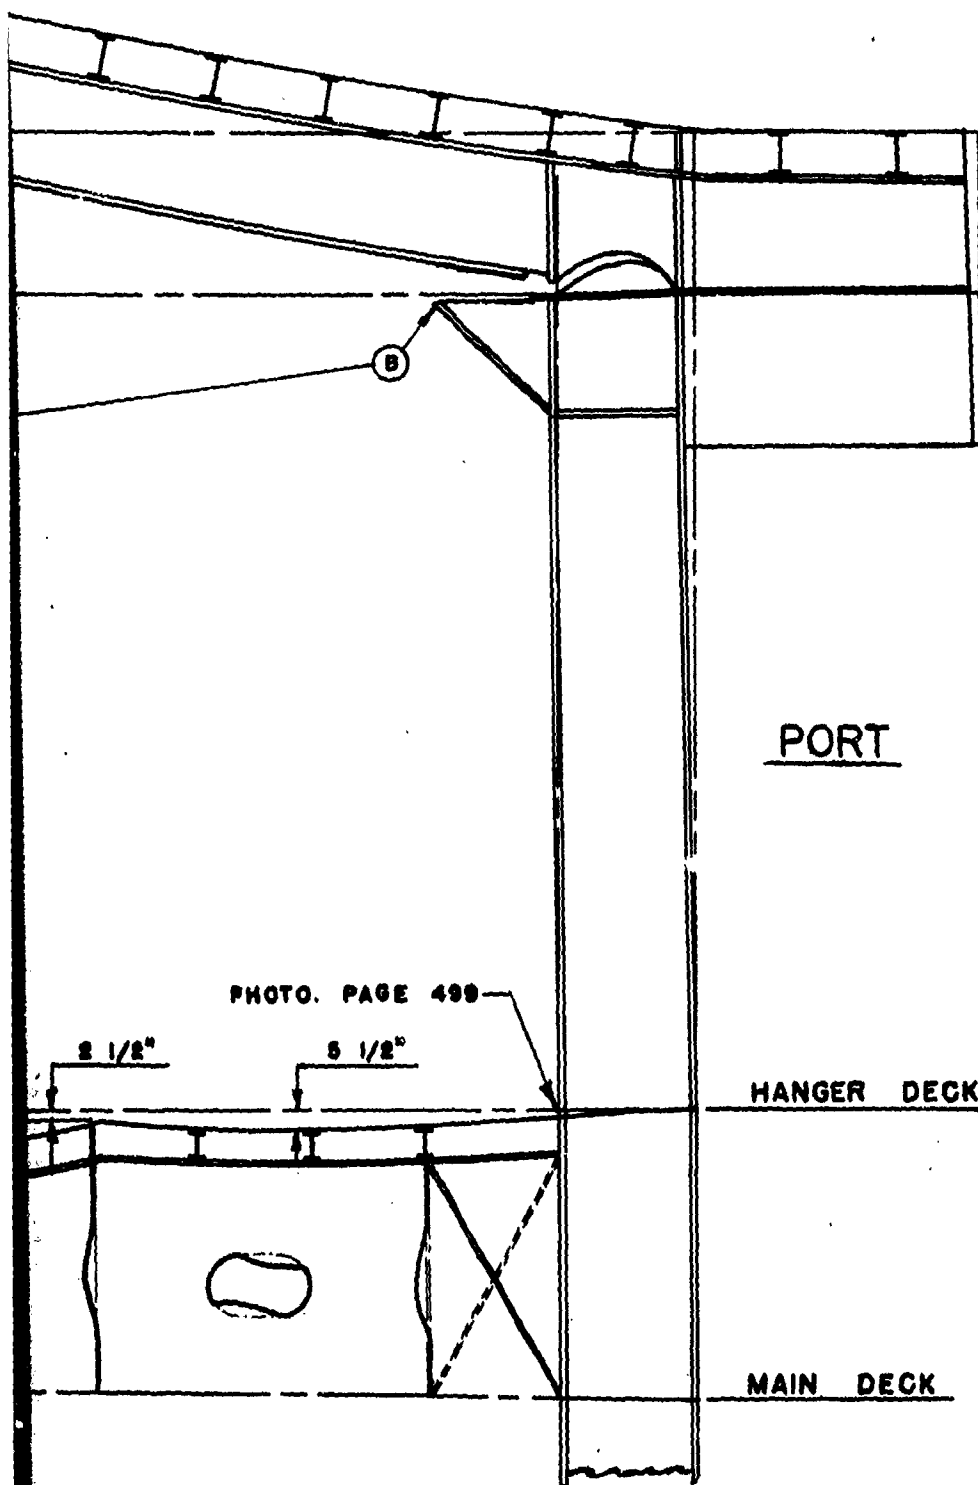
TRANSVERSE SECTION AT FR.101
LOOKING AFT

FRACTURED NEAR WELL
PHOTOS.- VOL. 3, PAGE

FRACTURE ORIGINATED
BRACKET FLANGE TO
OF BOTH STBD. (A)
CONNECTIONS. WELDS
DEVELOP 100% JOINT
PHOTOS.- VOL. 3, PAGE

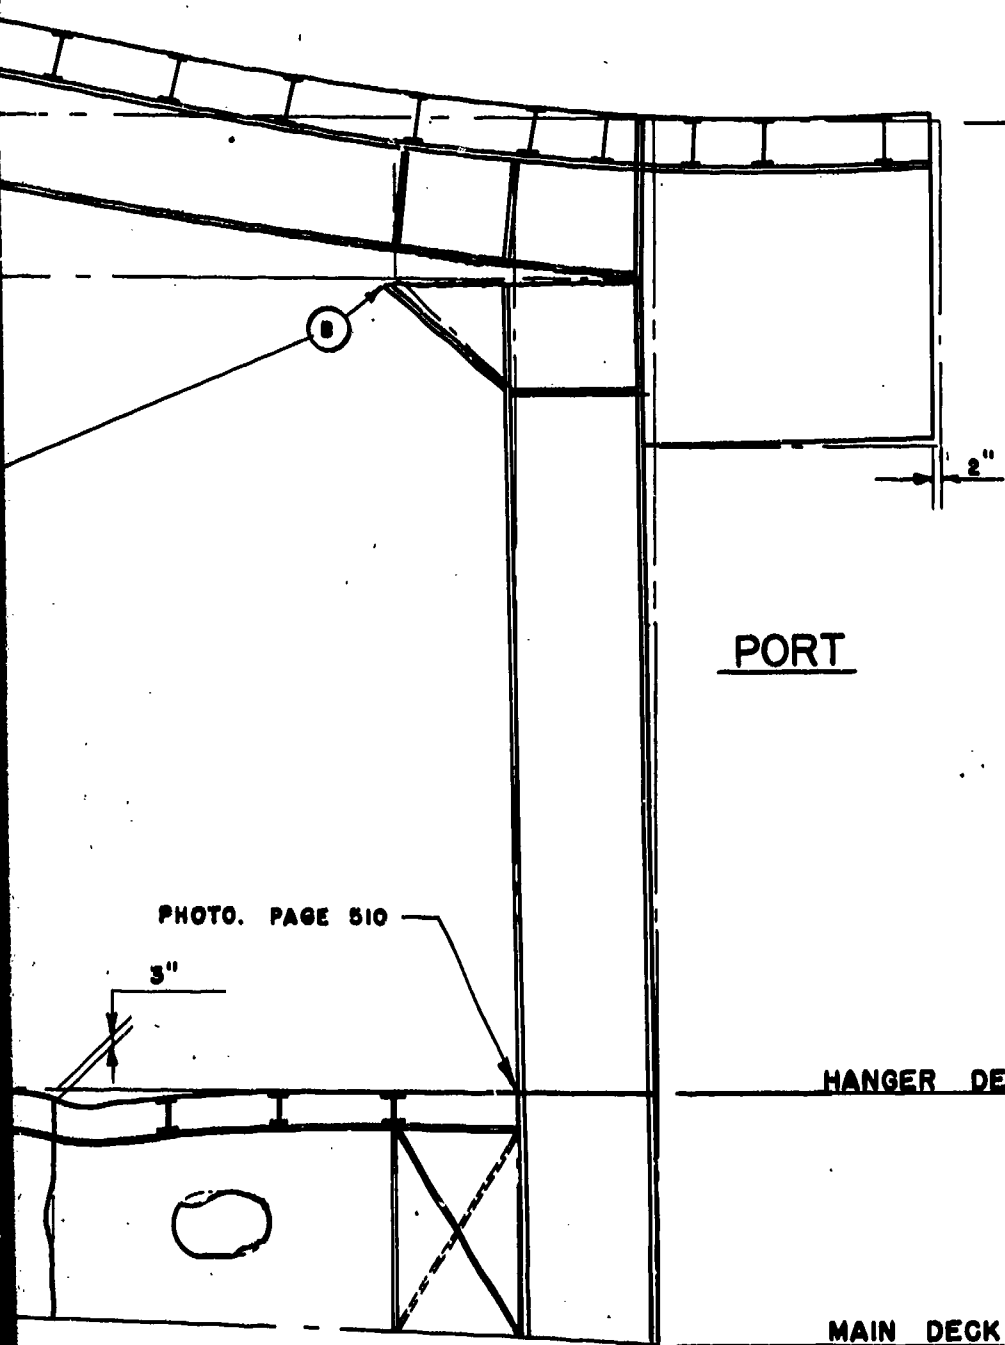
TRANSVERSE SECTION AT FR. 104
LOOKING AFT

FRACTURE ORIGINATED
OF BUTT WELD IN
GIRDER. INCOMPLETE
CONTRIBUTED TO FAILURE
PHOTOS.— VOL. 4, PAGE 518

FRACTURE ORIGINATED
BRACKET FLANGE TO
STARBOARD (A) AND
WELDS IN BOTH CASES
TO DEVELOP 100% JOINT
PHOTOS.— VOL. 4, PAGE 518
(A) 517, 518

FRACTURE ORIGINATED IN FORWARD END
OF BUTT WELD IN LOWER FLANGE OF
GIRDER. INCOMPLETE WELD PENETRATION
CONTRIBUTED TO FAILURE.

FRACTURE ORIGINATED IN WELDS JOINING
BRACKET FLANGE TO GIRDER IN BOTH
STARBOARD (A) AND PORT (B) CONNECTIONS.
WELDS IN BOTH CASES ARE TOO SMALL
TO DEVELOP 100% JOINT EFFICIENCY.

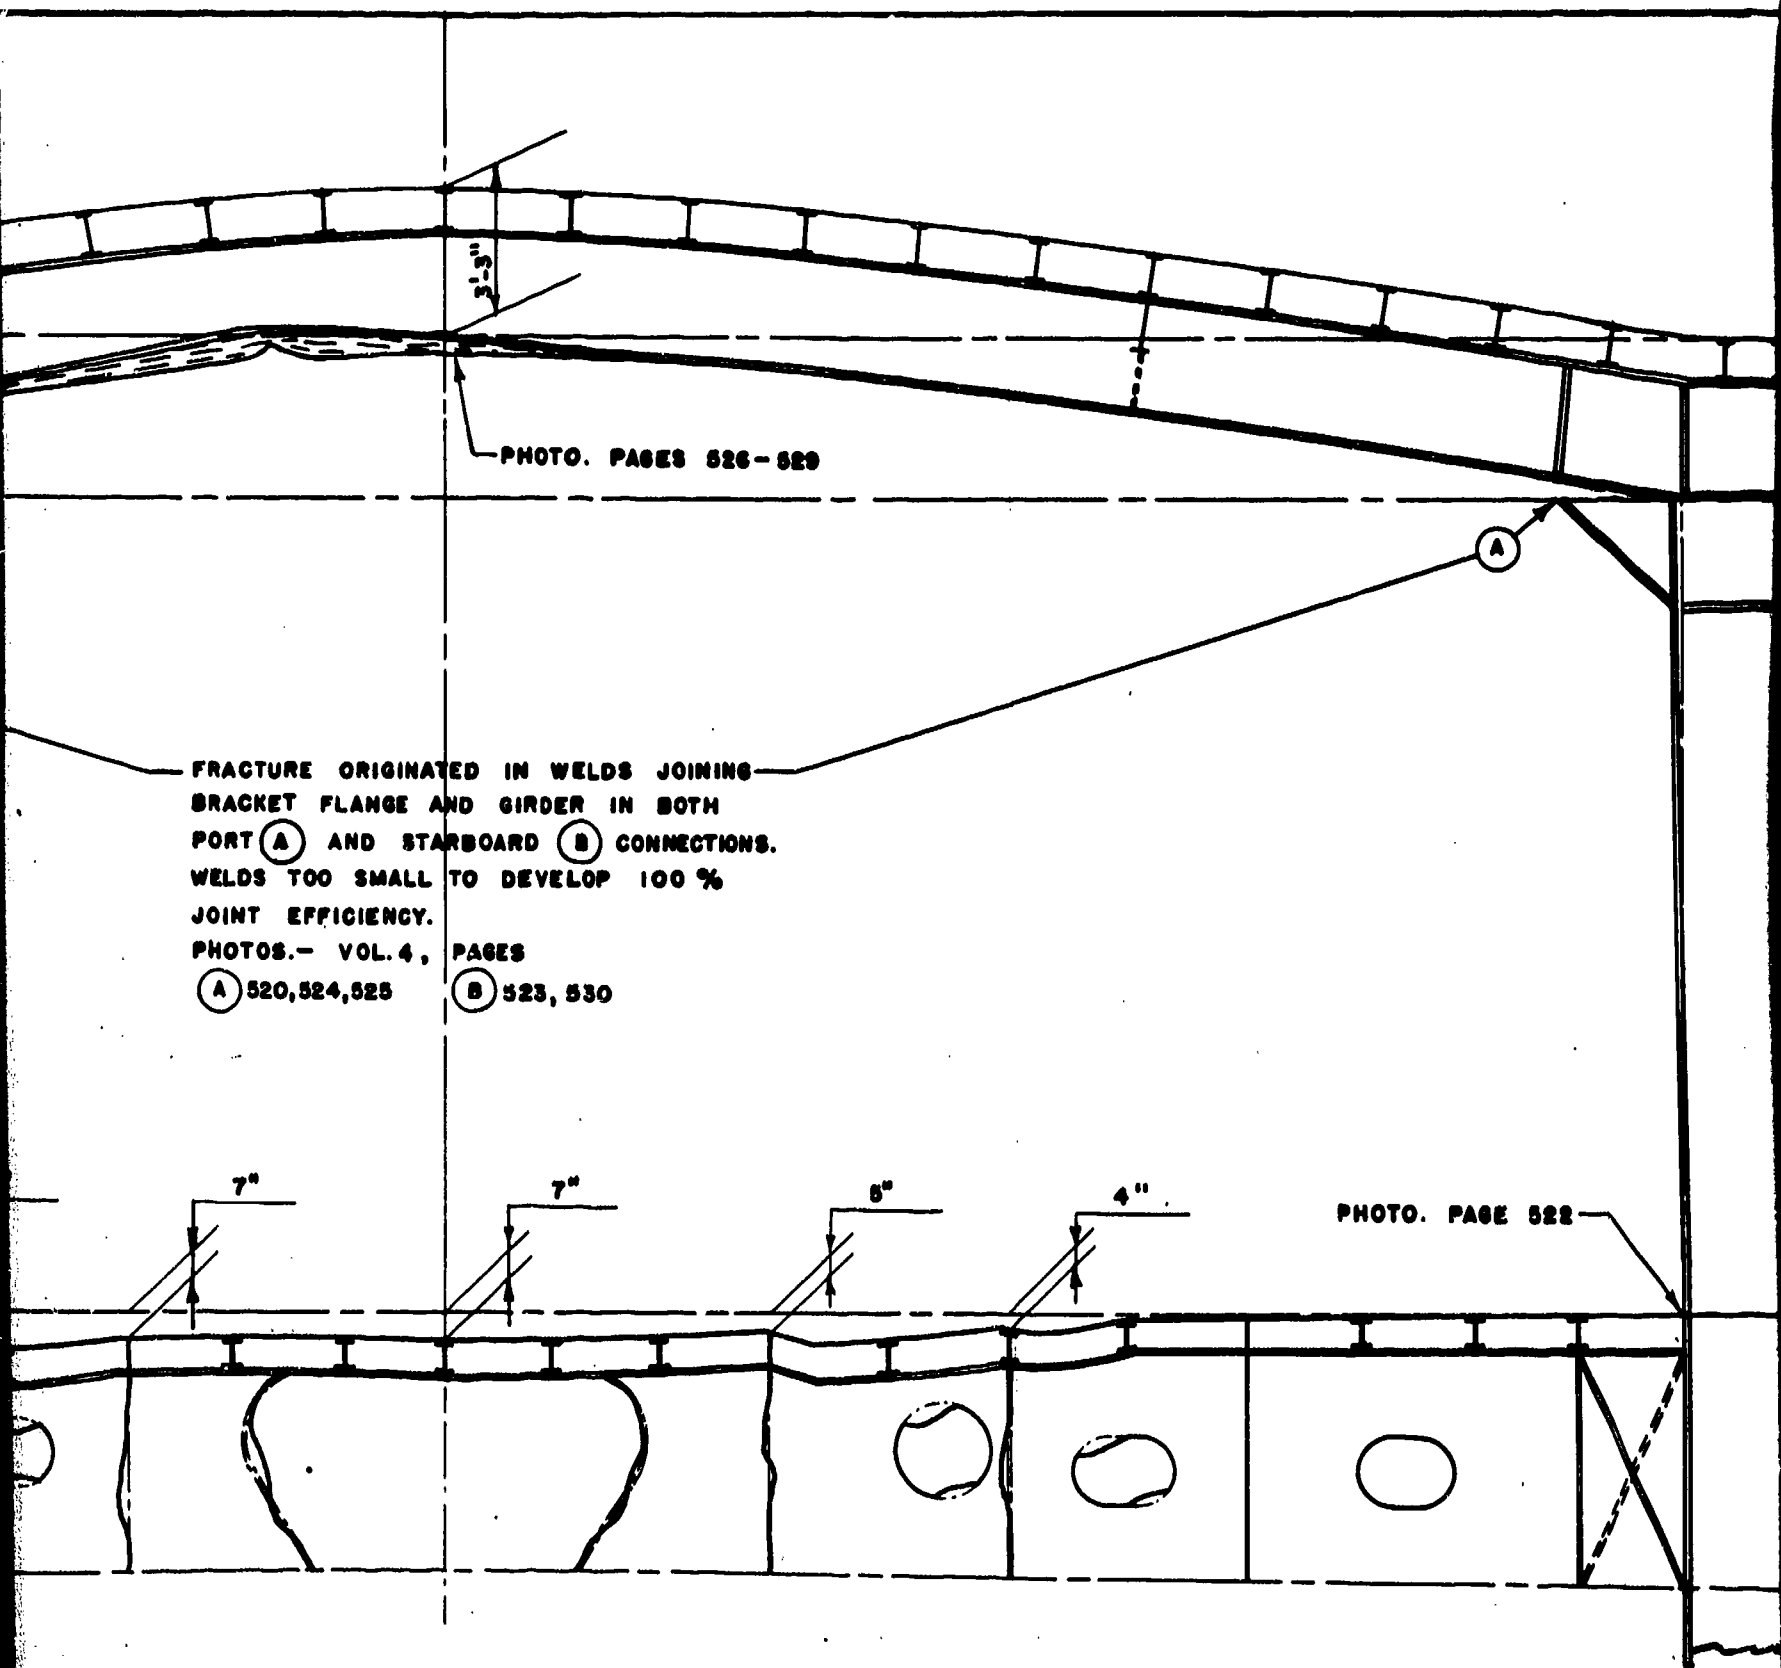
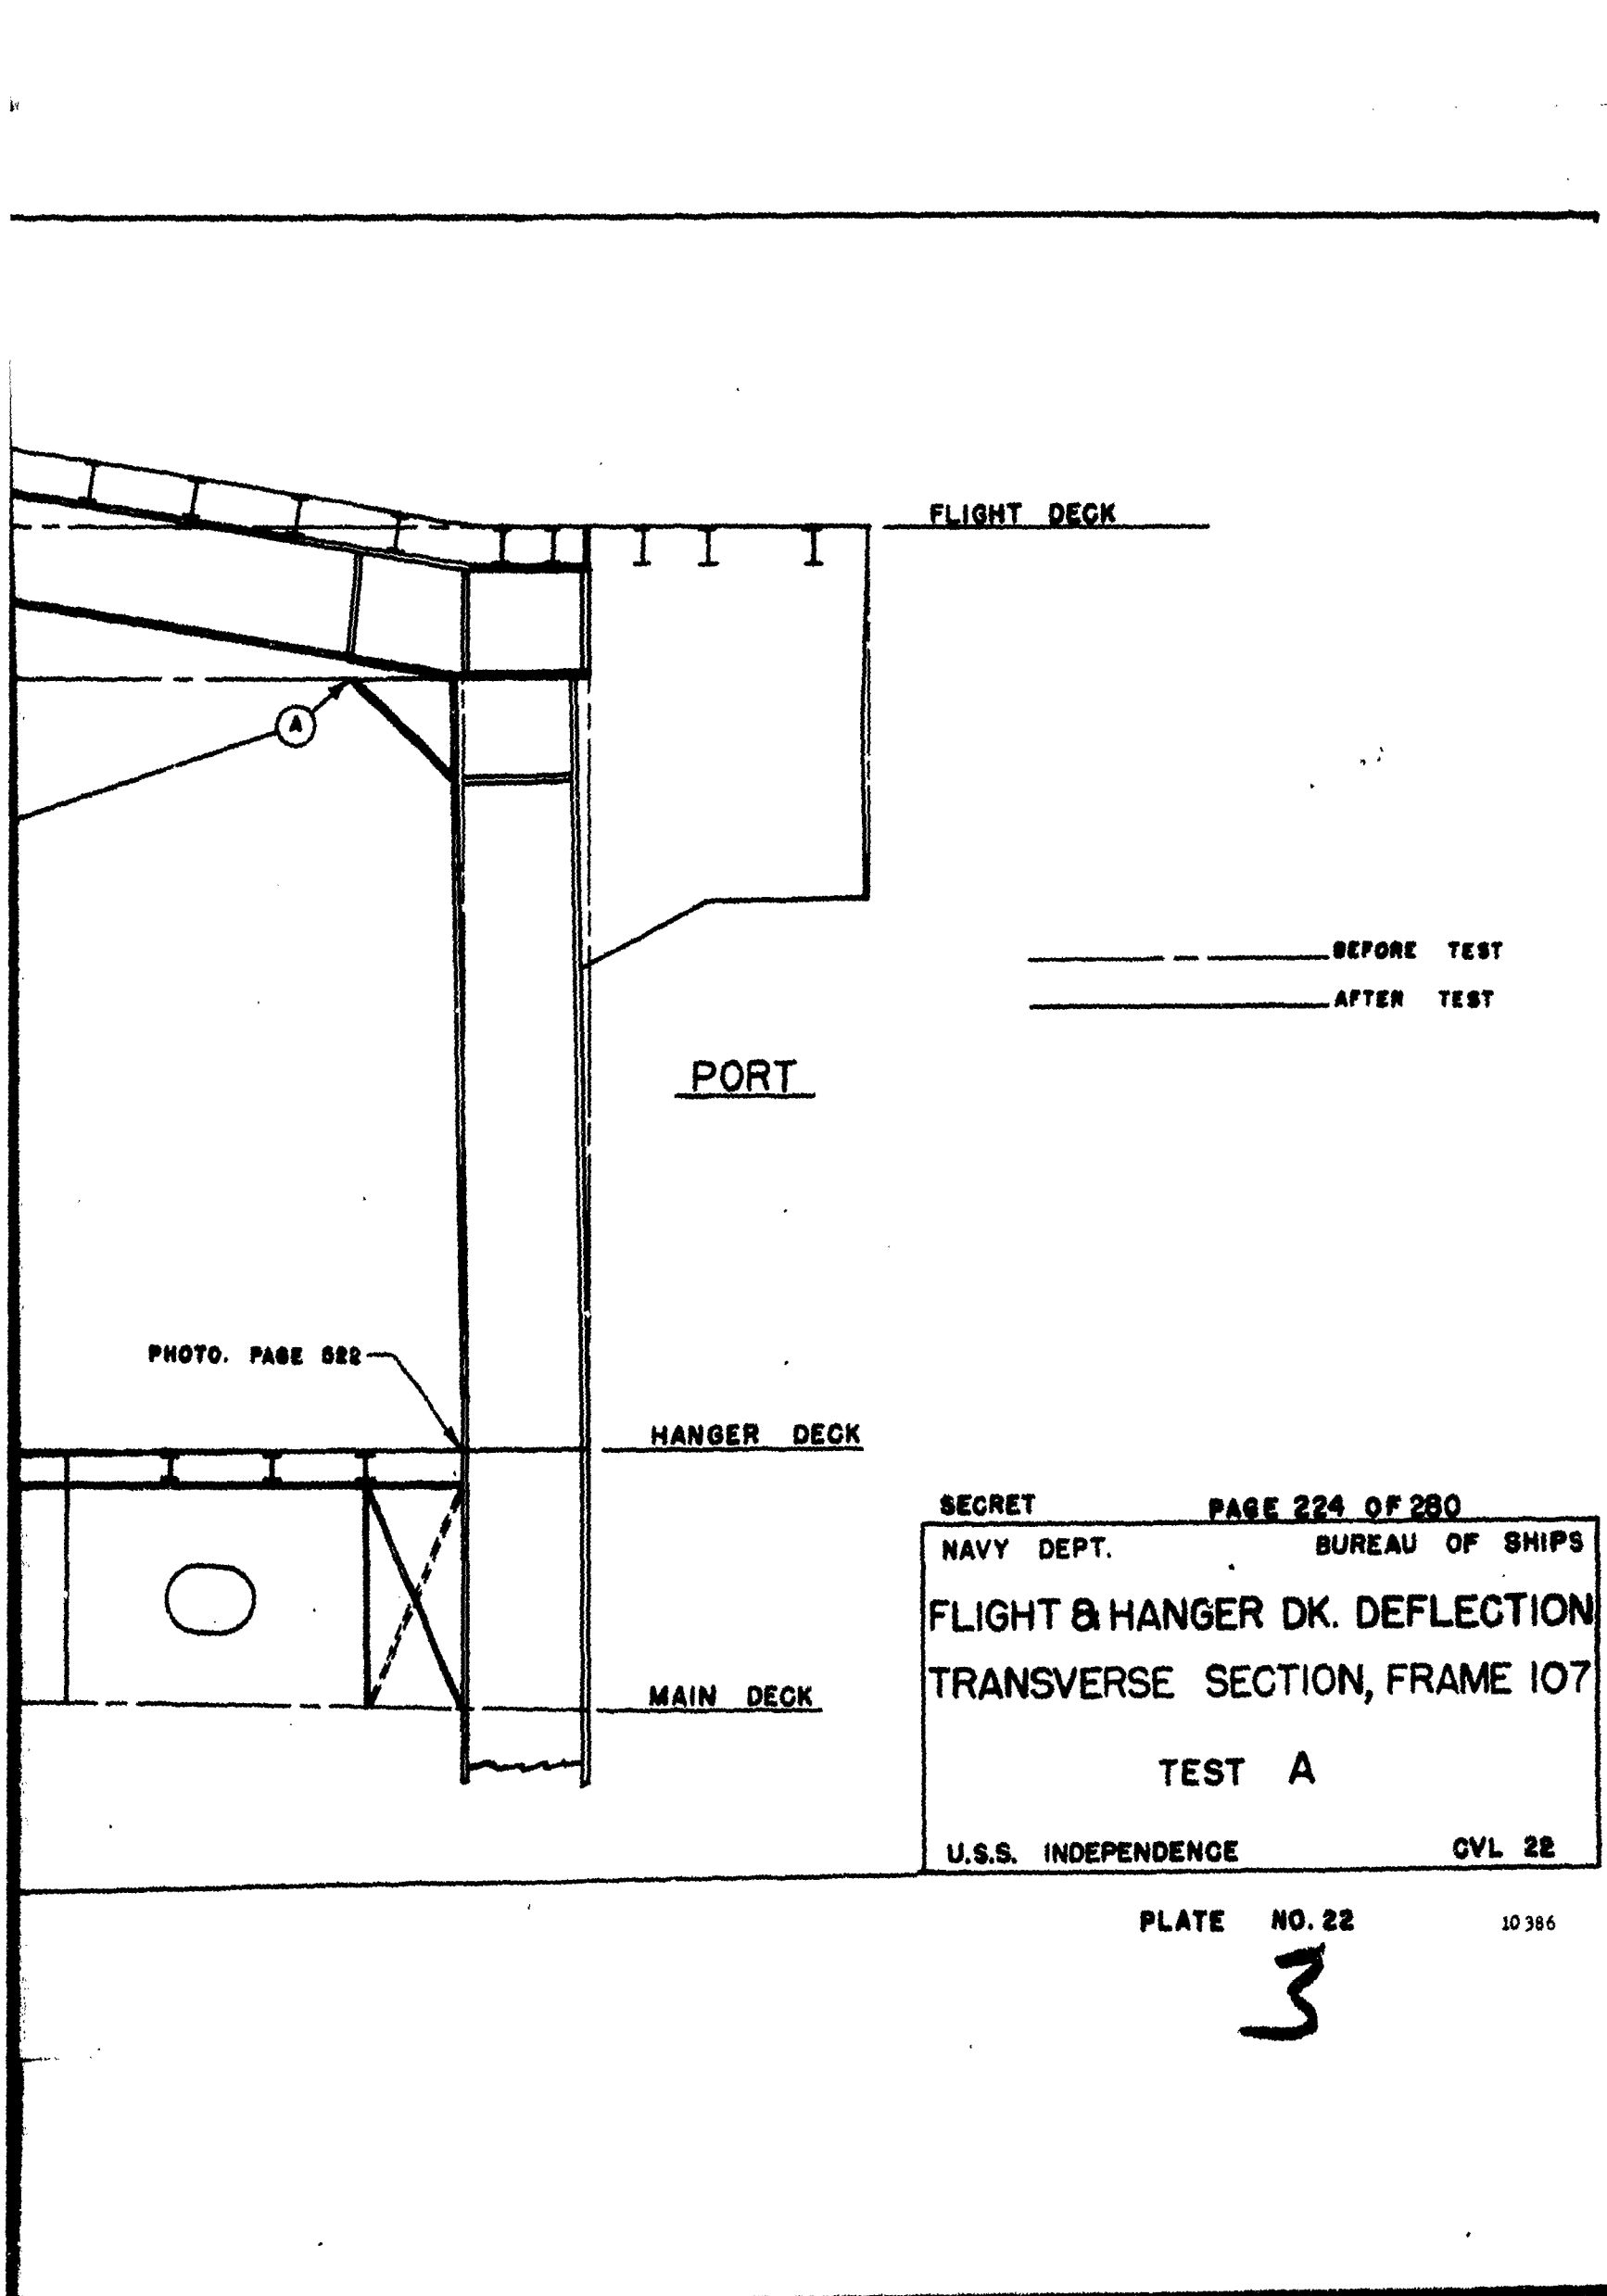
TRANSVERSE SECTION AT FR. 107
LOOKING AFT

FRACTURE ORIGIN
BRACKET FLANGE
PORT (A) AND 2
WELDS TOO SMALL
JOINT EFFICIENCY
PHOTOS. - VOL. 4
(A) 520, 524, 525

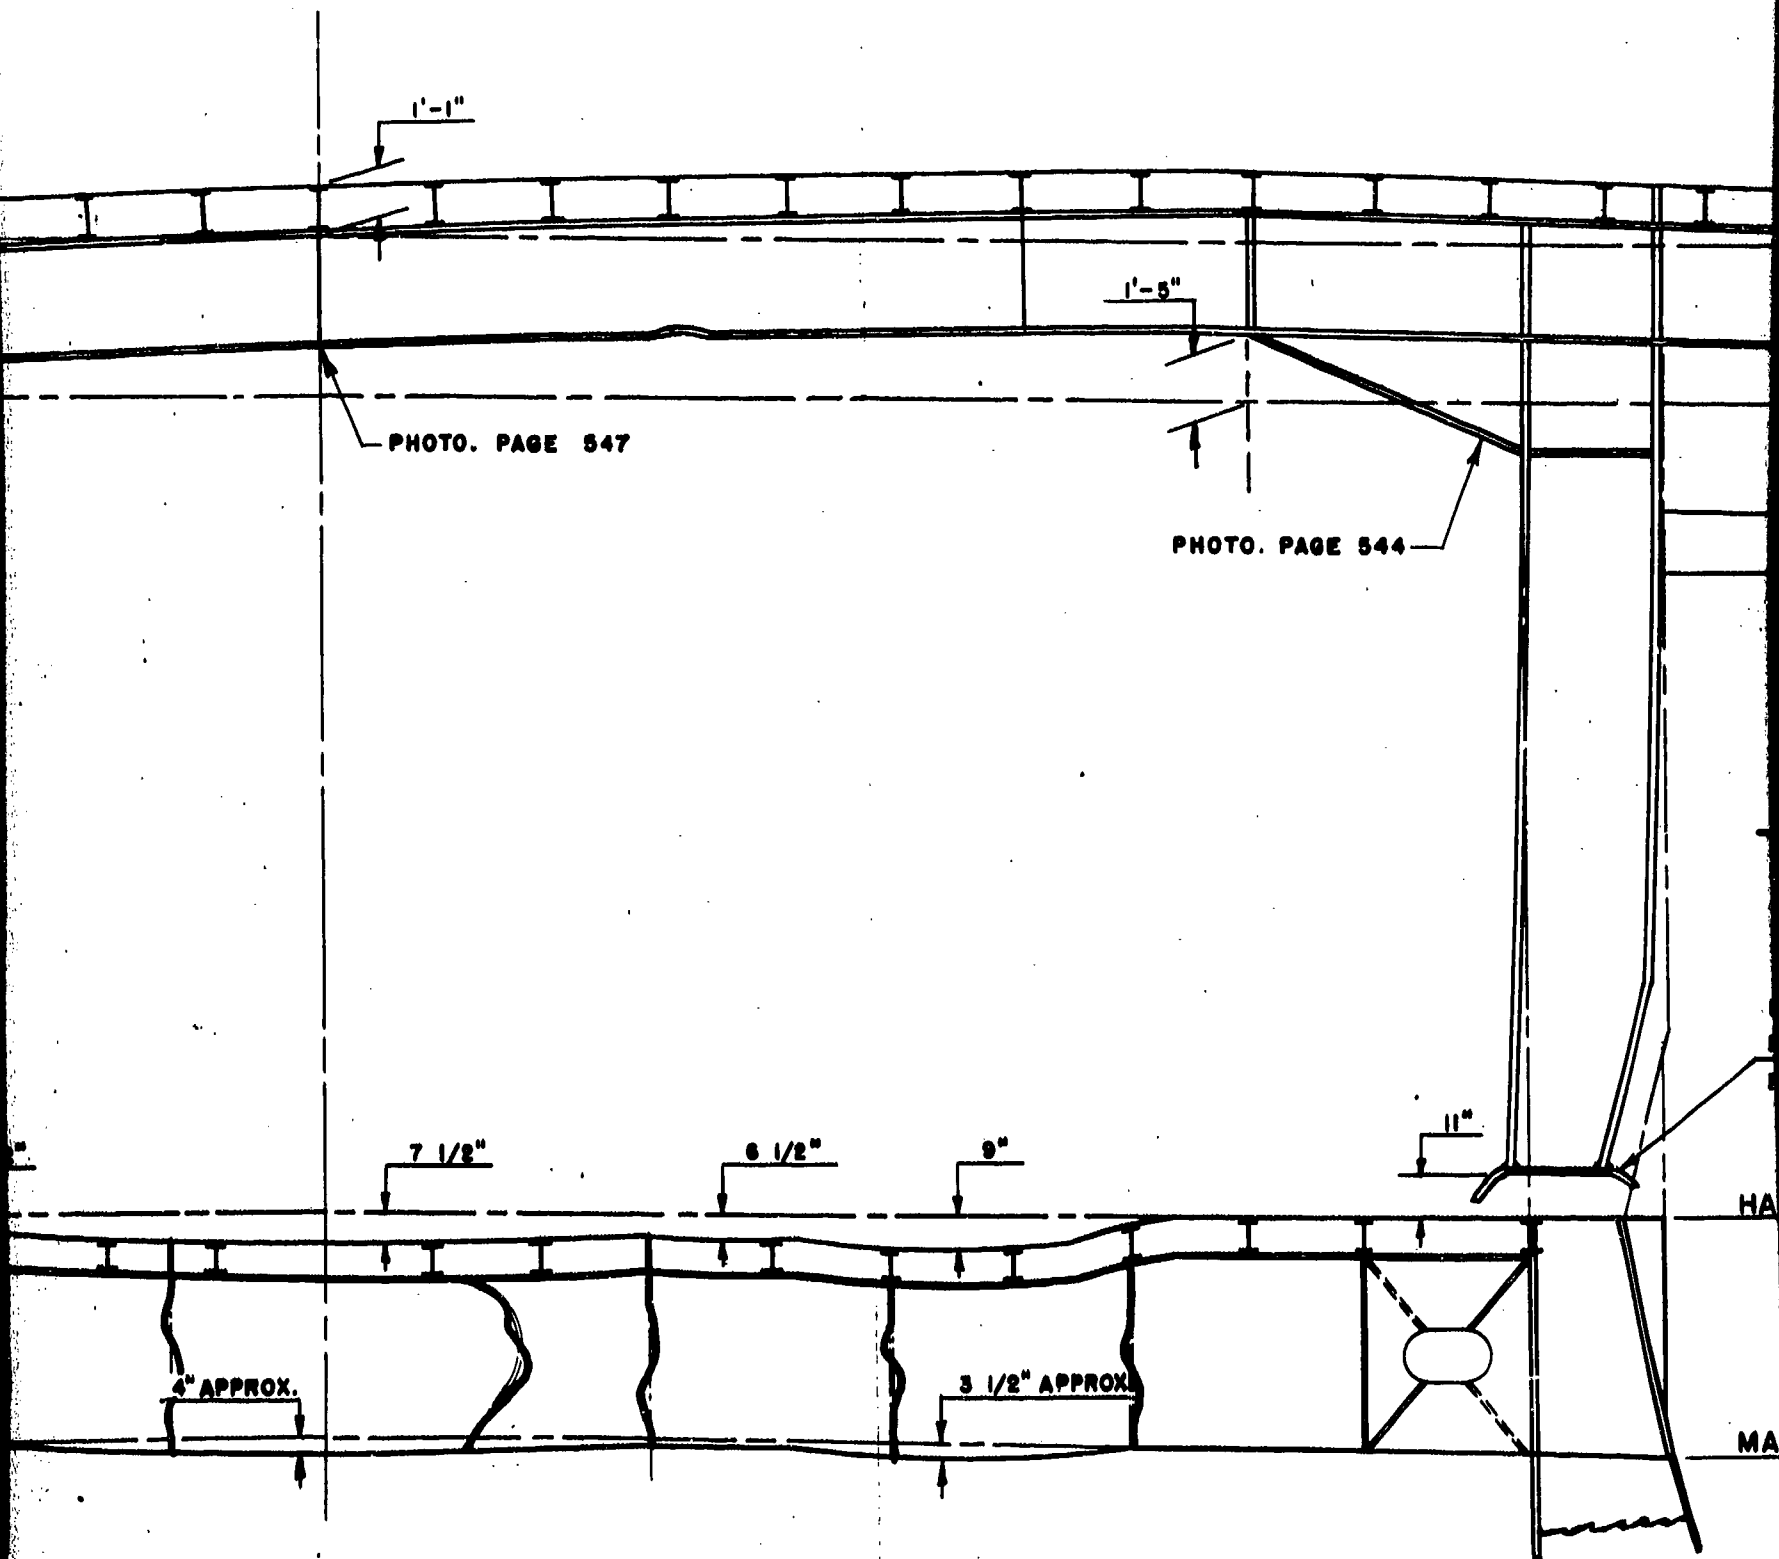
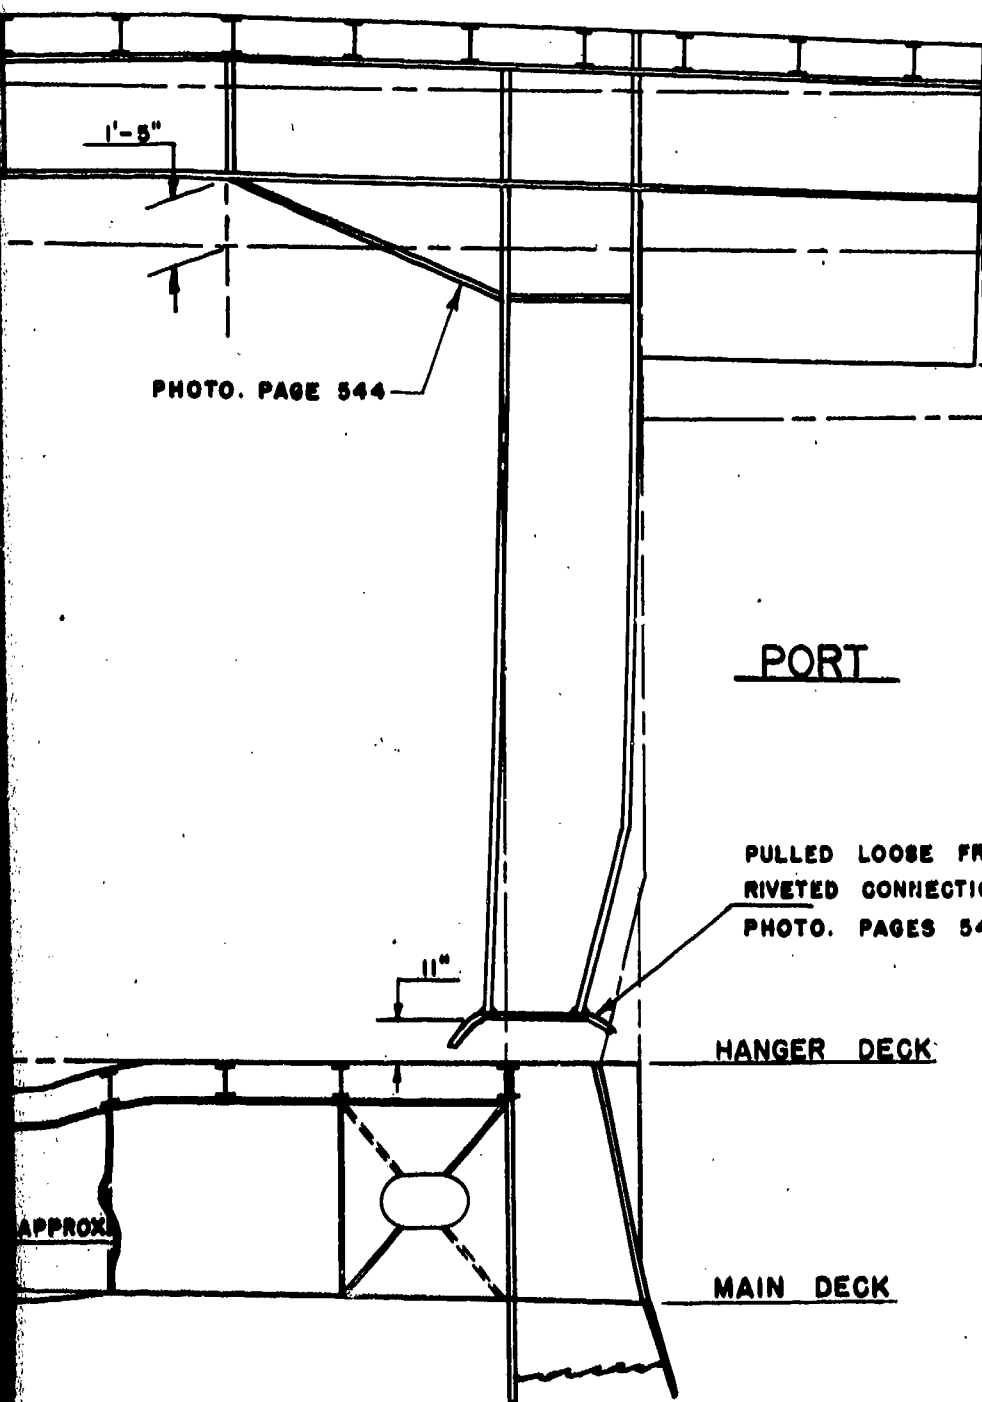
TRANSVERSE SECTION AT FR. 113
LOOKING AFT

PULLED LOOSE FROM DECK AT
RIVETED CONNECTION.
PHOTO. PAGES 545, 546
